# ArmorTek® Protects Vegas Infrastructure from MIC-Related Corrosion

**Location:**  
Las Vegas, NV

**Industry:**  
Municipal Water Utility

**Solution:**  
ArmorTek® Advanced Coating System

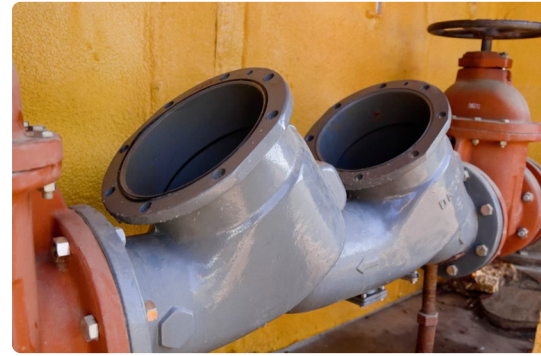
The corroded valve in Las Vegas was replaced with a new version of the same valve, this time coated with ArmorTek. A third-party study was conducted to test the effectiveness of ArmorTek over a span of 10,000 hours. The study found that valves without ArmorTek corrode approximately 14x as quickly as an ArmorTek coated valve. This seemed like a great solution to this customer's corrosion problems.
