Protecting
Valves from
Corrosion

ArmorTek is a micro-composite coating with superior adhesion and abrasion resistance qualities which resists undercutting and aggressive water. Additionally, the ArmorTek coating features an antimicrobial agent to protect the valve against the adverse impacts of MIC.

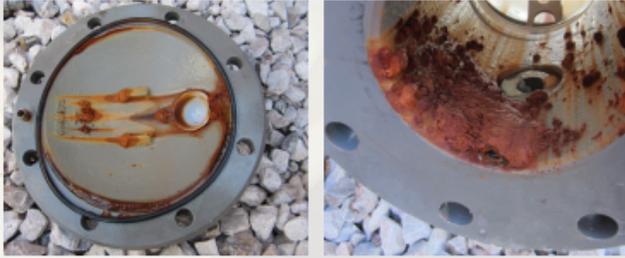
In these images taken 14 months after installation you can see many of the tubercles common to MIC and extensive corrosion.

After only 14 months, a valve with standard epoxy coating was filled with corrosion indicative of MIC activity. The valve was swapped with one using ArmorTek technology, and after 16 months corrosion was extremely limited.

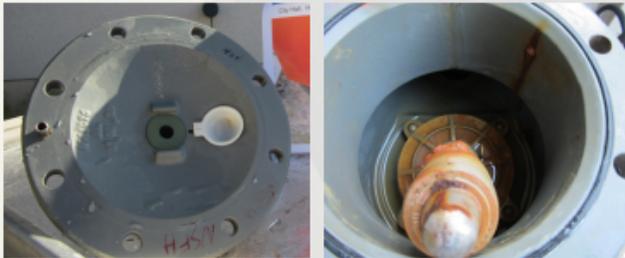
These images taken after 16 months in the same application as above shows little to no corrosion. Any corrosion resulting from a breach in coating has not spread.

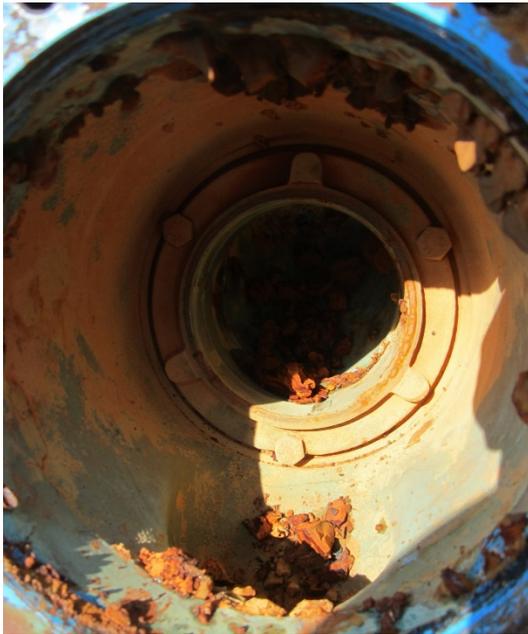
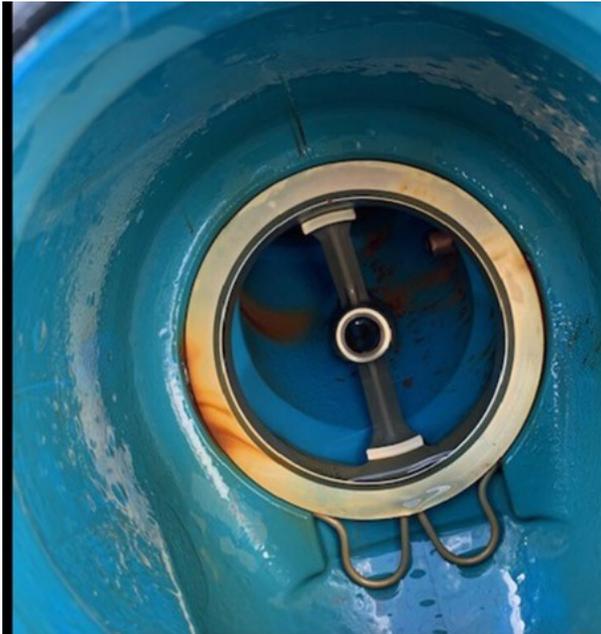
The results of a field study completed in 2022, show a comparison between the effects of corrosion after five years with a standard coating (left) versus the ArmorTek coating (right) on a backflow preventer.
