# ArmorTek™

Advanced Coating System

## ArmorTek™ Advanced Coating System

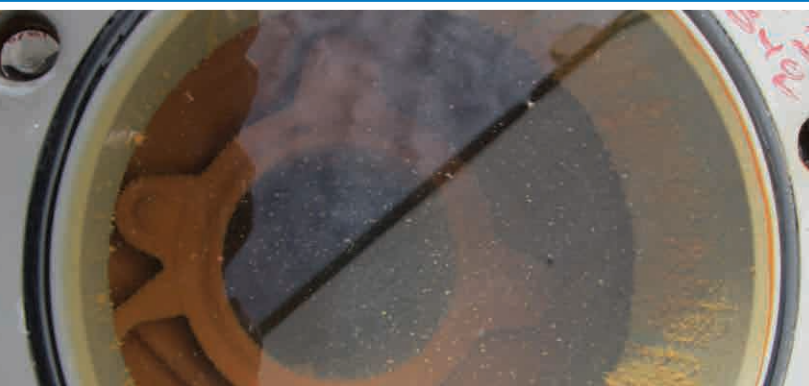
**Without**  
ArmorTek Coating

But when epoxy coating is breached, iron exposed to water corrodes  
and in some cases the water chemistry is just right for bacteria that can  
accelerate corrosion, known as microbial-induced corrosion (MIC).

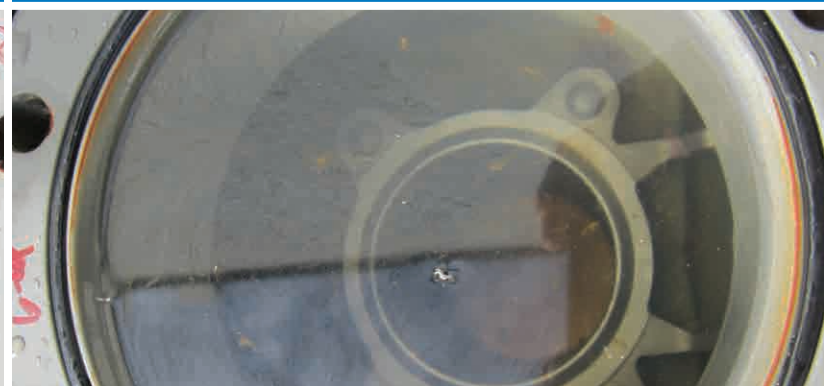
**With**  
ArmorTek Coating

#### 1: Anti-corrosion primer

An advanced primer contains an electrochemical corrosion inhibitor that will significantly slow the spread of corrosion should the metal substrate become exposed from wear or impact.

#### 2: Microbial inhibitor

ArmorTek's exclusive formulation prohibits the growth of the bacteria that cause MIC, further slowing the spread of corrosion and limiting the growth of tubercles that can clog or foul downstream equipment.

#### 3: Robust topcoat

ArmorTek's top layer is specially designed to bond to the primer below, providing a high strength barrier between the iron substrate and water.

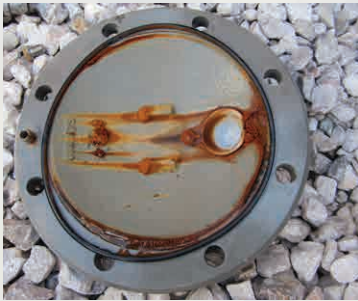
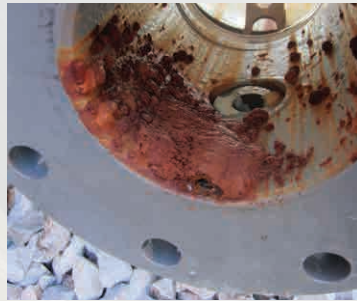
After only 14 months, a valve with standard epoxy coating was filled with corrosion indicative of MIC activity. The valve was swapped with one using ArmorTek technology, and after 16 months corrosion was extremely limited.

In these images taken 14 months after installation you can see many of the tubercles common to MIC and extensive corrosion.

In an area where the water was tested to have low chlorine levels and significant MIC activity, a municipality was experiencing accelerated corrosion and failure of a valve that experienced low, infrequent flow.

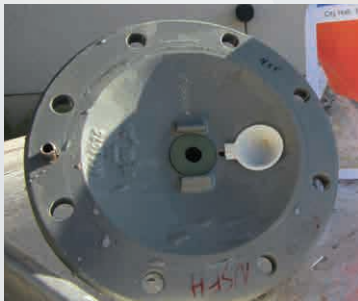
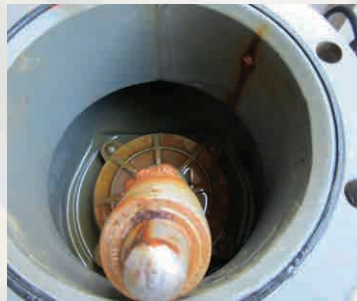
These images taken after 16 months in the same application as above shows little to no corrosion. Any corrosion resulting from a breach in coating has not spread.

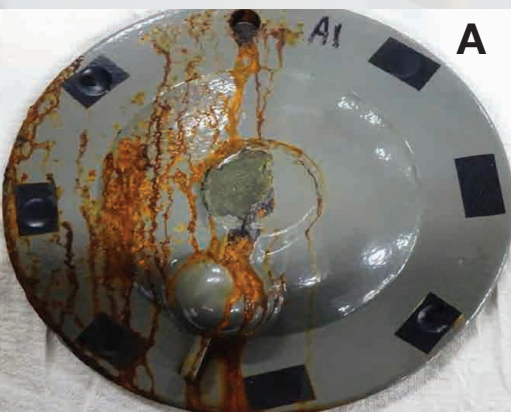
**A**

### Standard Coating (A) vs. ArmorTek Coating (B)

We sent two valve covers to an independent lab, who scribed them with a grinder to expose the base iron to a VERY corrosive salt fog environment for 10,000 hours. Each valve was then evaluated to see how corrosion “creeped,” or how far to the sides of the scribe the corrosion had spread. The study concluded that the standard coating crept at a rate over 14 times\* that of the ArmorTek coating. They also determined that the ArmorTek coating had appr. 6x less surface rusting\*\*.

*\*Utilizing ASTM D1654 Method 1 for evaluation of Degree of Corrosion*

*\*\* Utilizing ASTM 610 evaluation for Degree of Rusting*
